# **RAISIN RIVER HERITAGE CENTRE BUILDING CONDITIONS REPORT**

**TOWNSHIP OF SOUTH STORMONT**

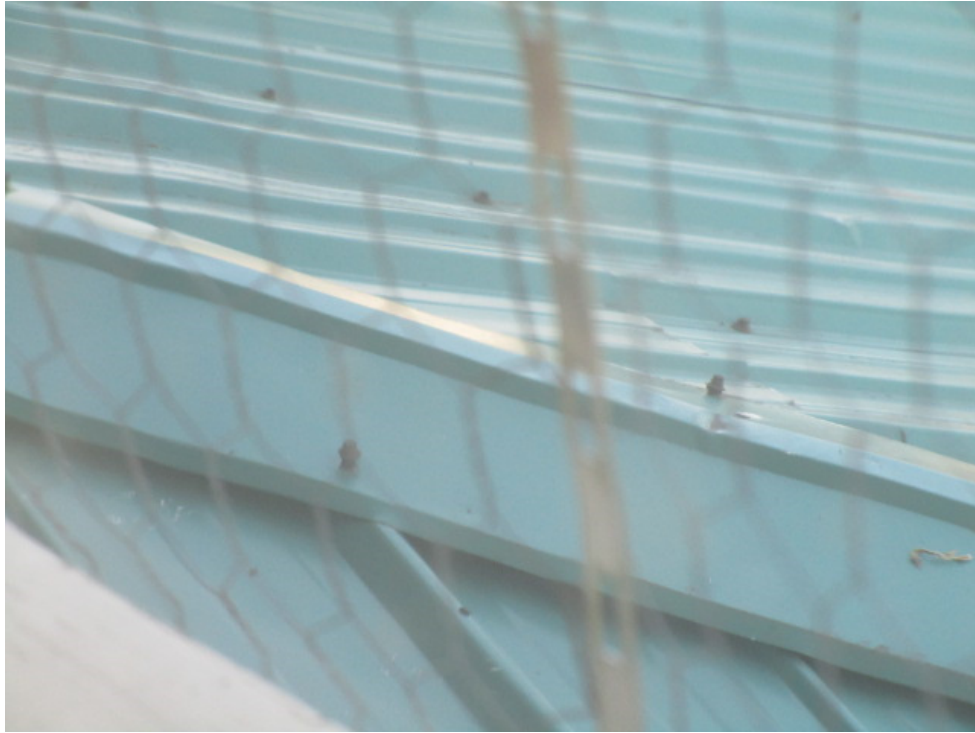
Photo 5 – Loose Roof Panel Fasteners

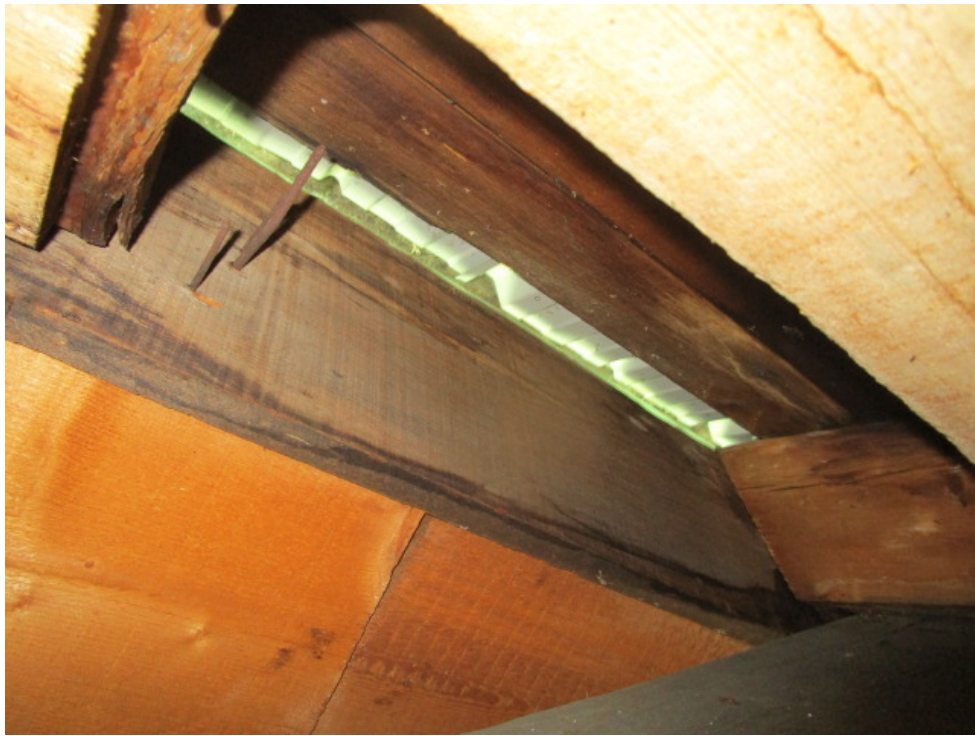
Photo 6 – Suspected Opening In Roof Flashing

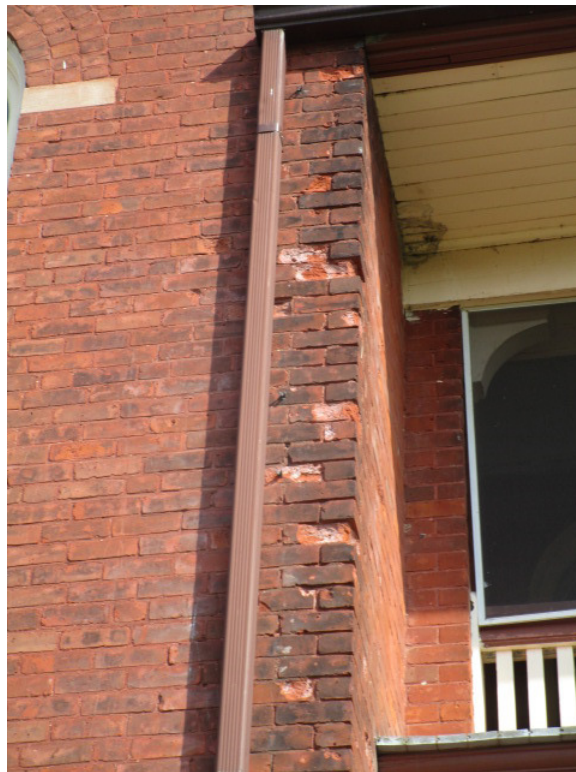
**Photo 8 – Brick Masonry Deterioration**

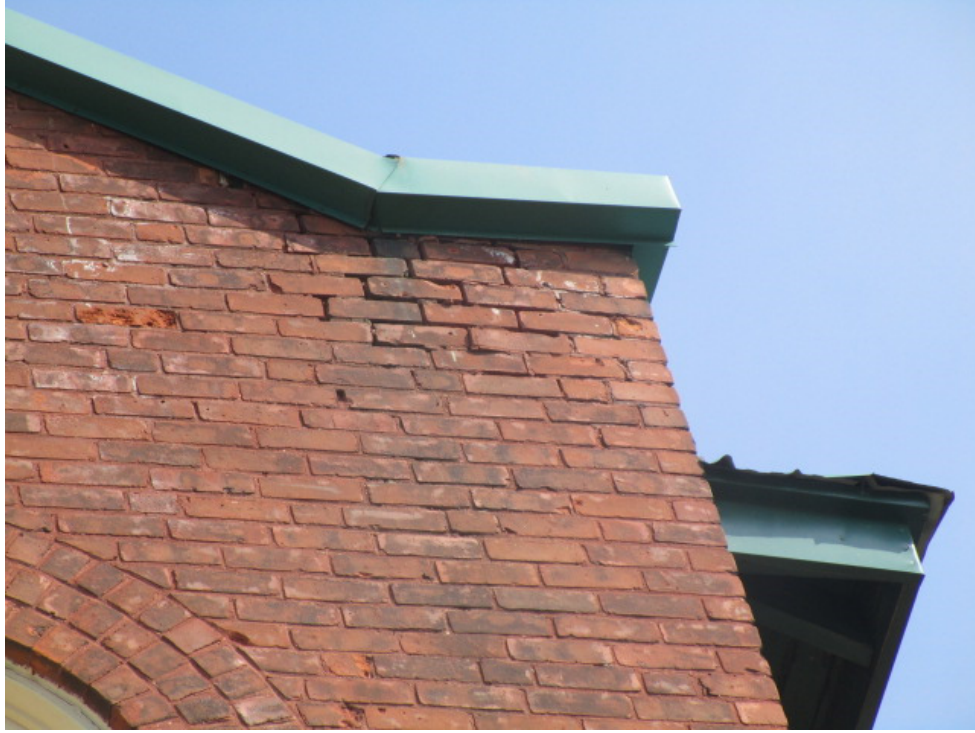
**Photo 9 – Brick Masonry Deterioration**

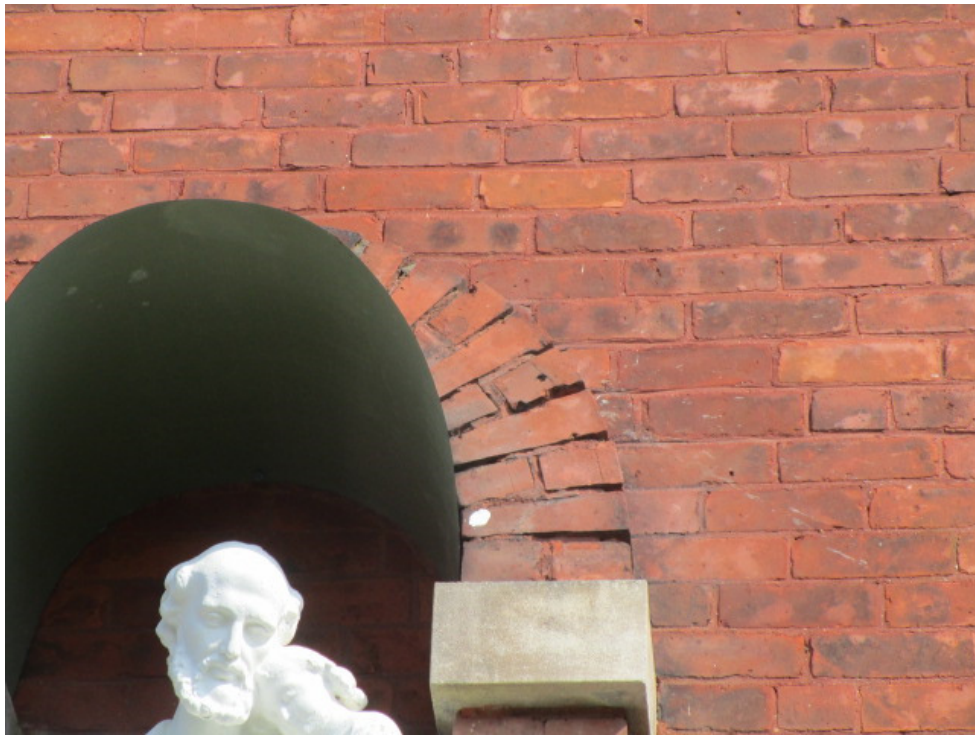
**Photo 10 – Brick Masonry Deterioration**

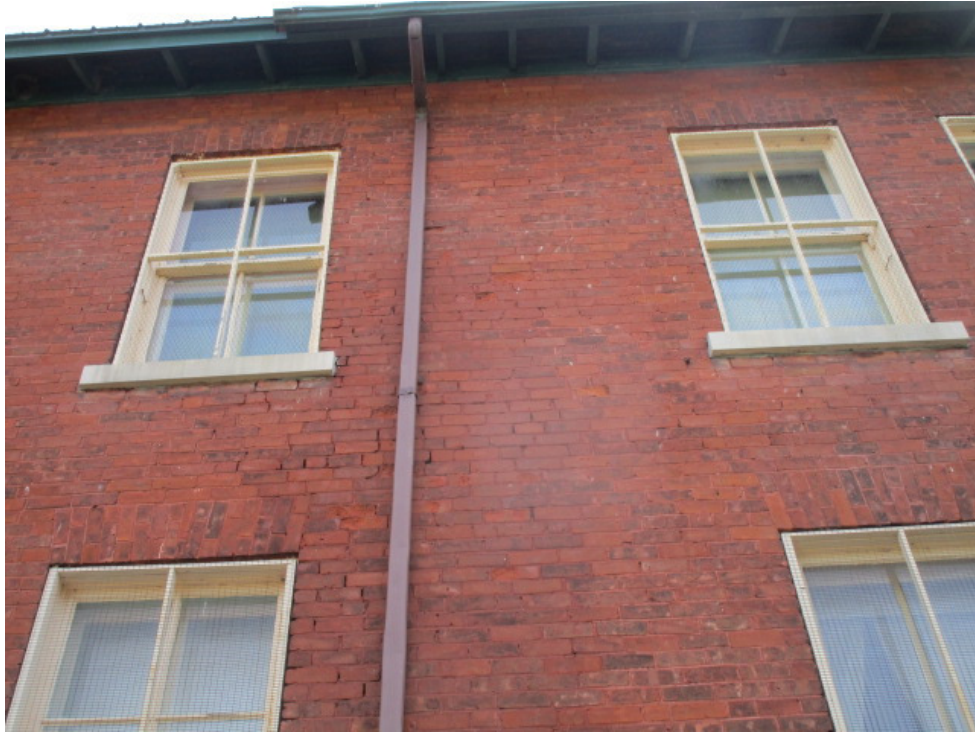
**Photo 11 – Brick Masonry Deterioration**

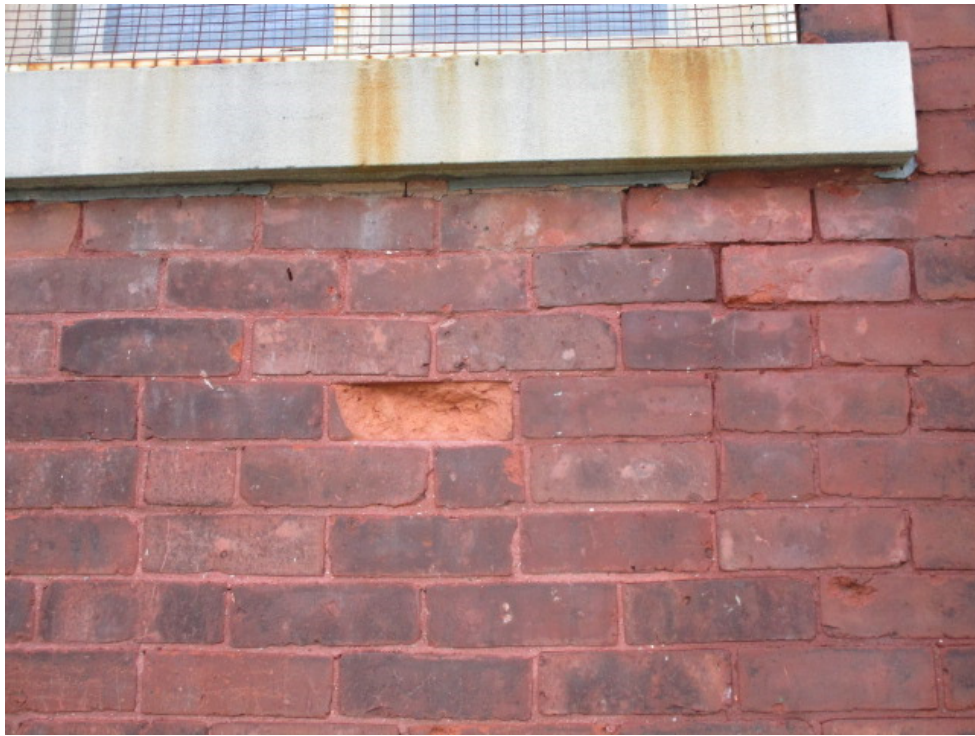
**Photo 12 – Brick Masonry Deterioration**

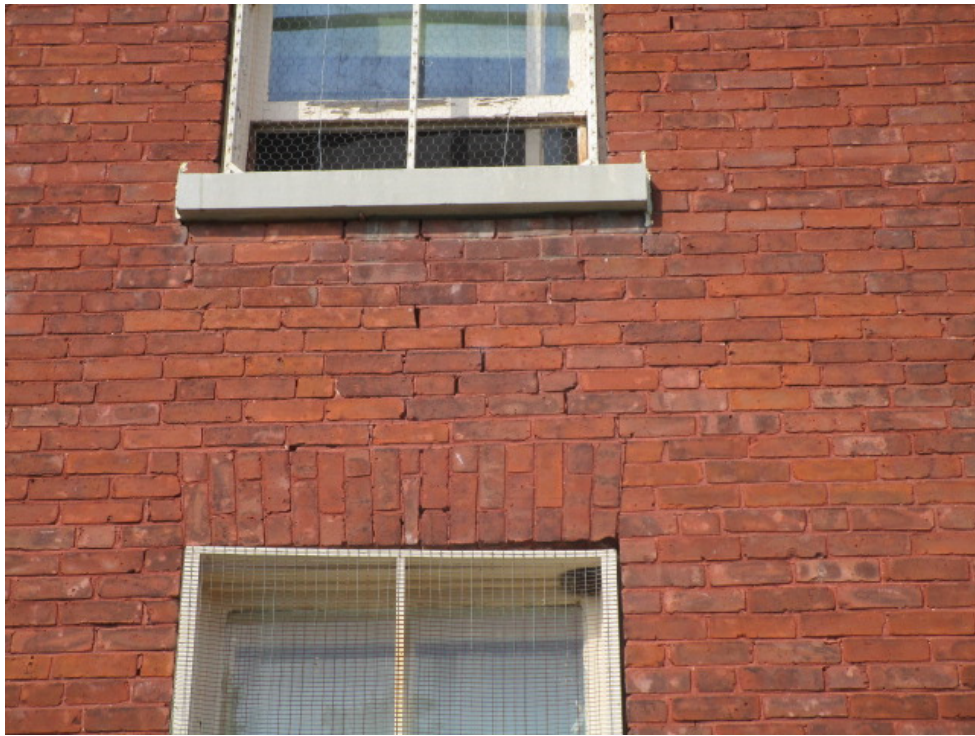
**Photo 13 – Brick Masonry Deterioration**

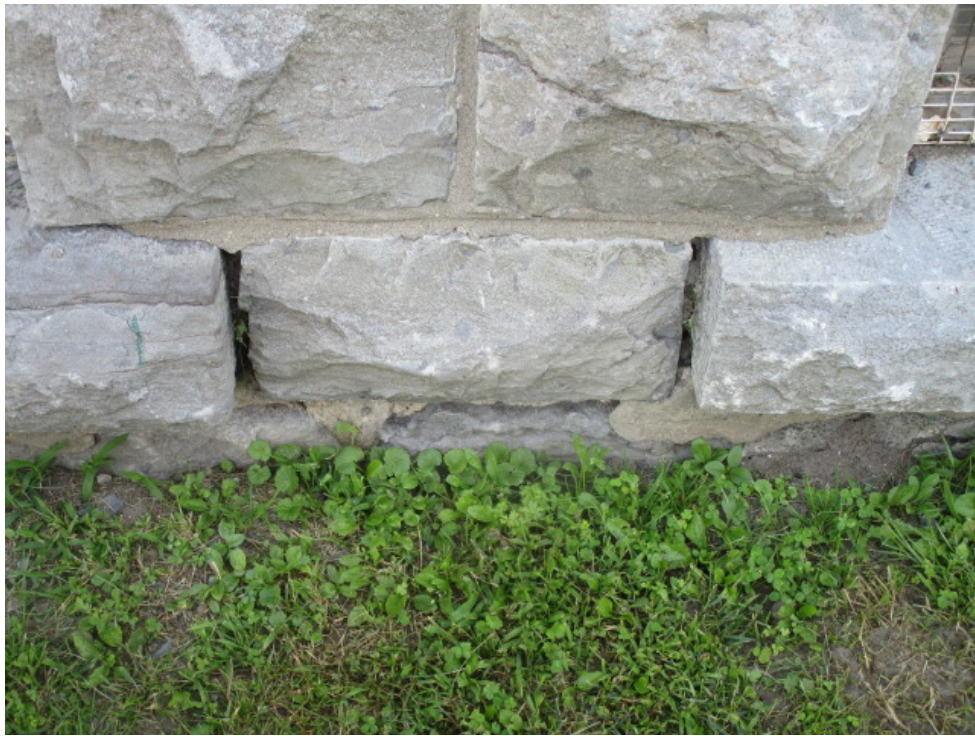
**Photo 14 – Stone Masonry Deterioration**

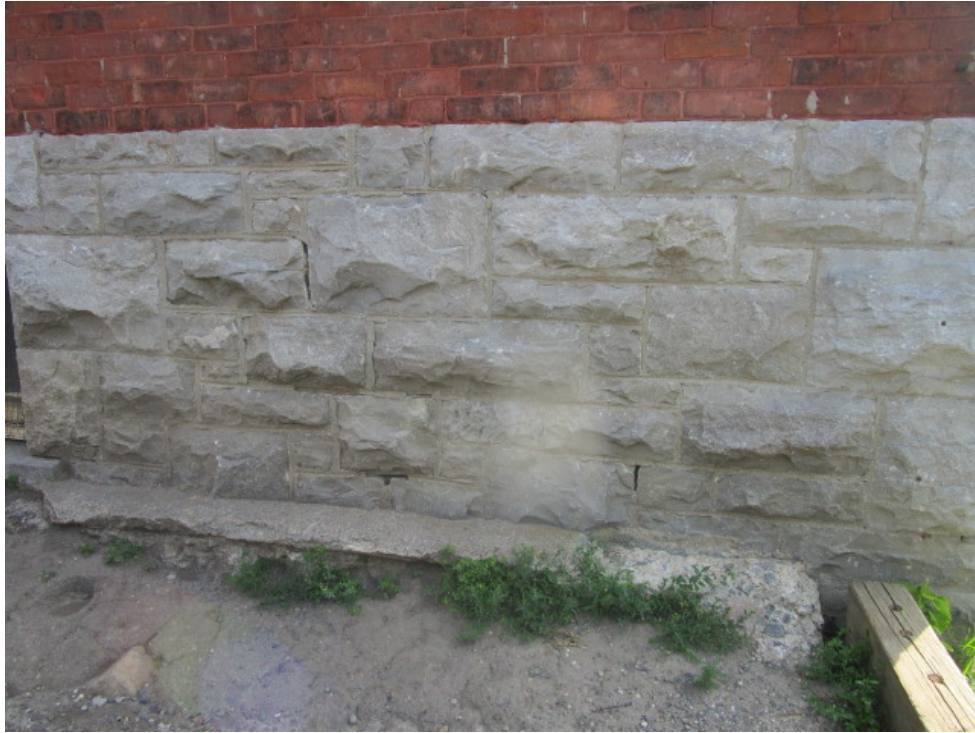
**Photo 15 – Stone Masonry Deterioration**

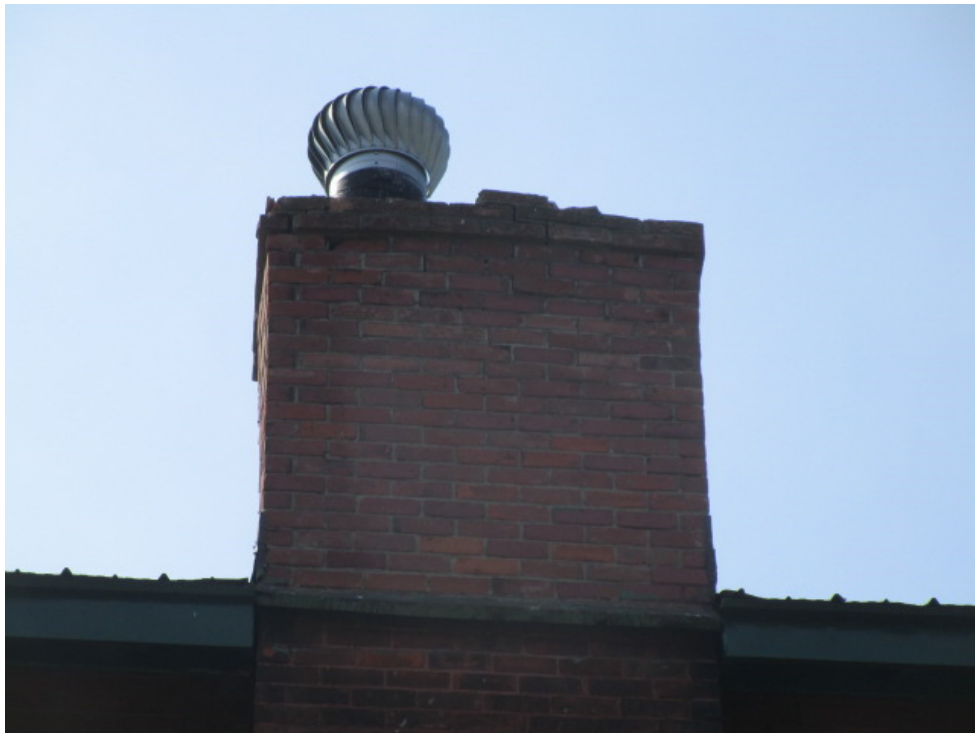
**Photo 16 – Chimney Brick Masonry Deterioration**

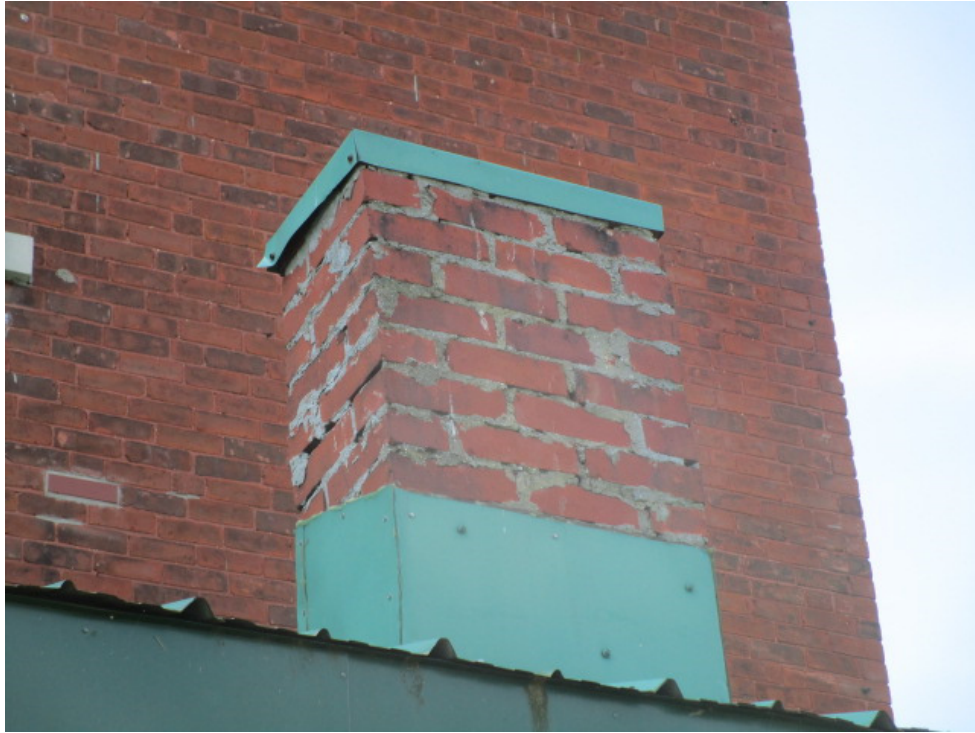
Photo 17 – Chimney Brick Masonry Deterioration

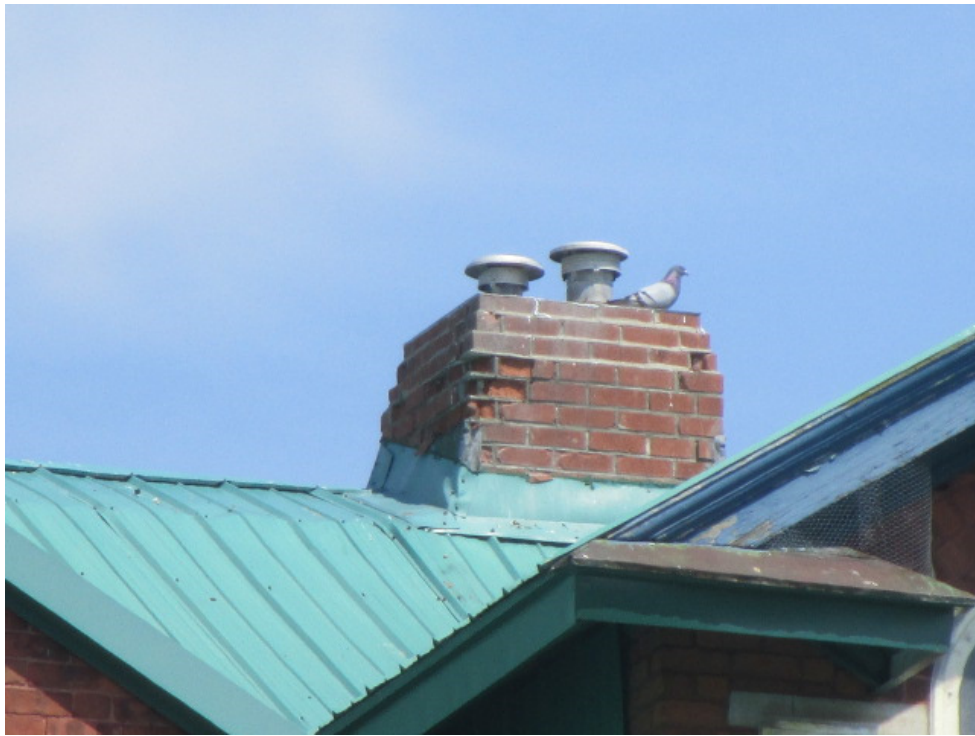
Photo 18 – Chimney Brick Masonry Deterioration

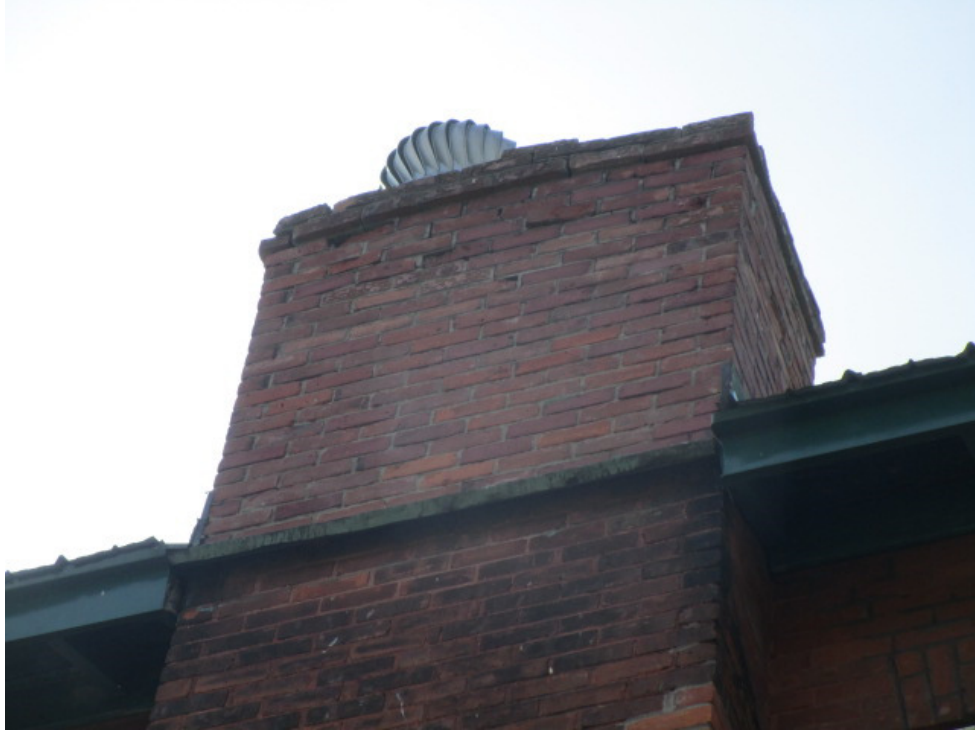
Photo 19 – Chimney Loose Brick Masonry

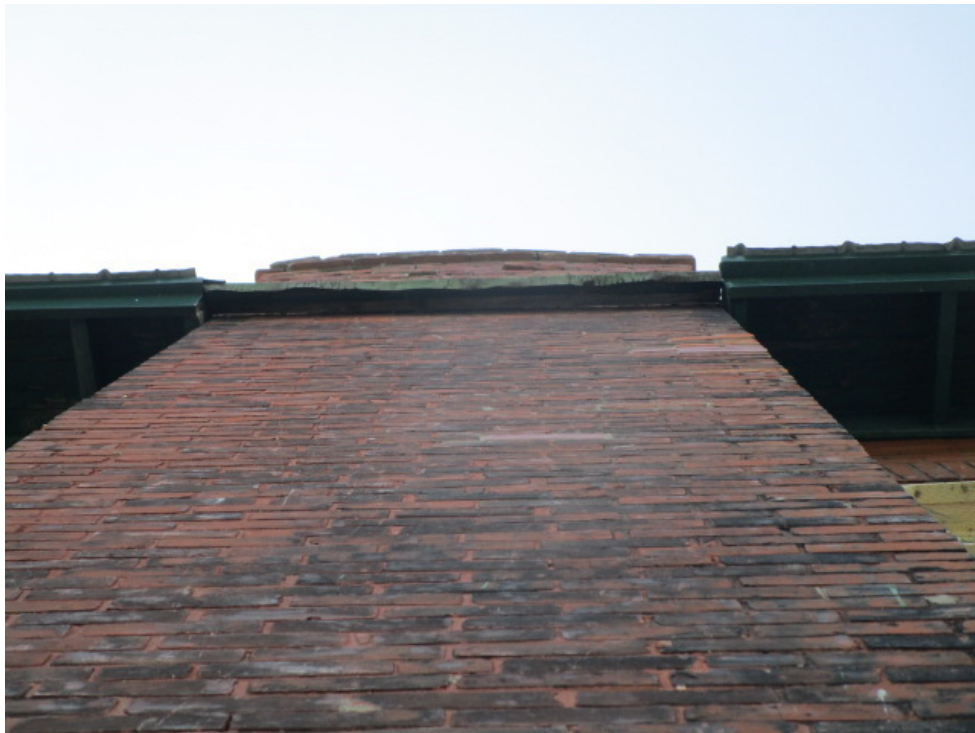
Photo 20 – Chimney Loose Brick Masonry

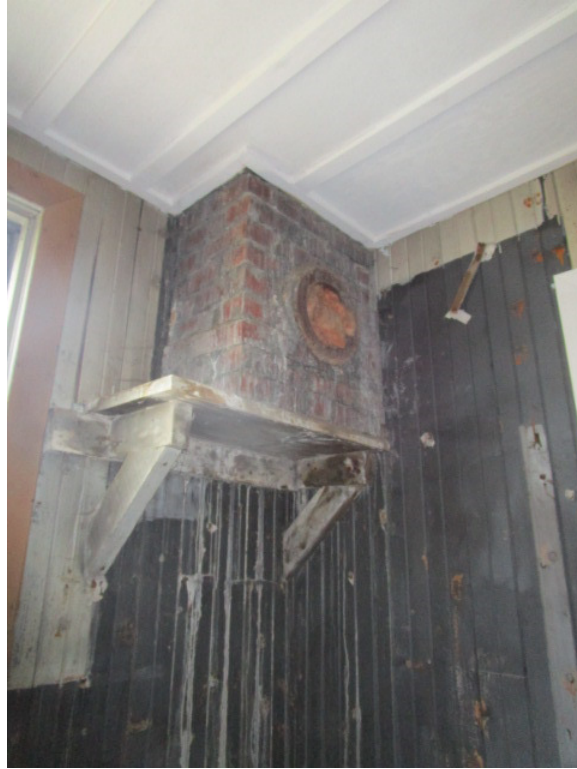
**Photo 21 – Chimney Structural Support**

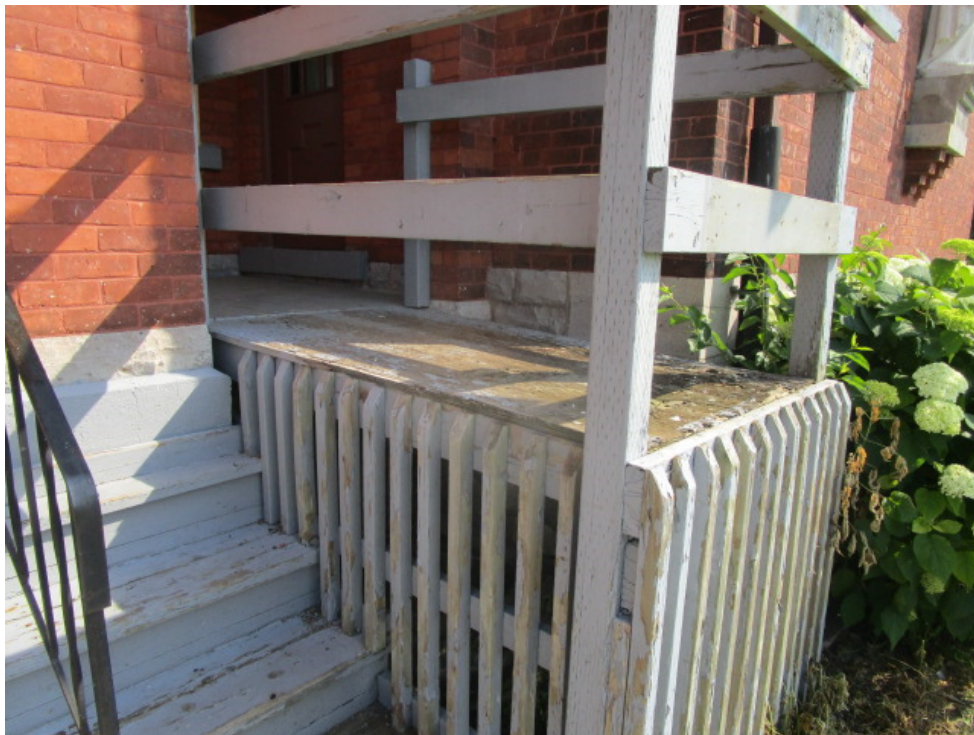
**Photo 22 – Front Entrance Landing And Stair Condition**

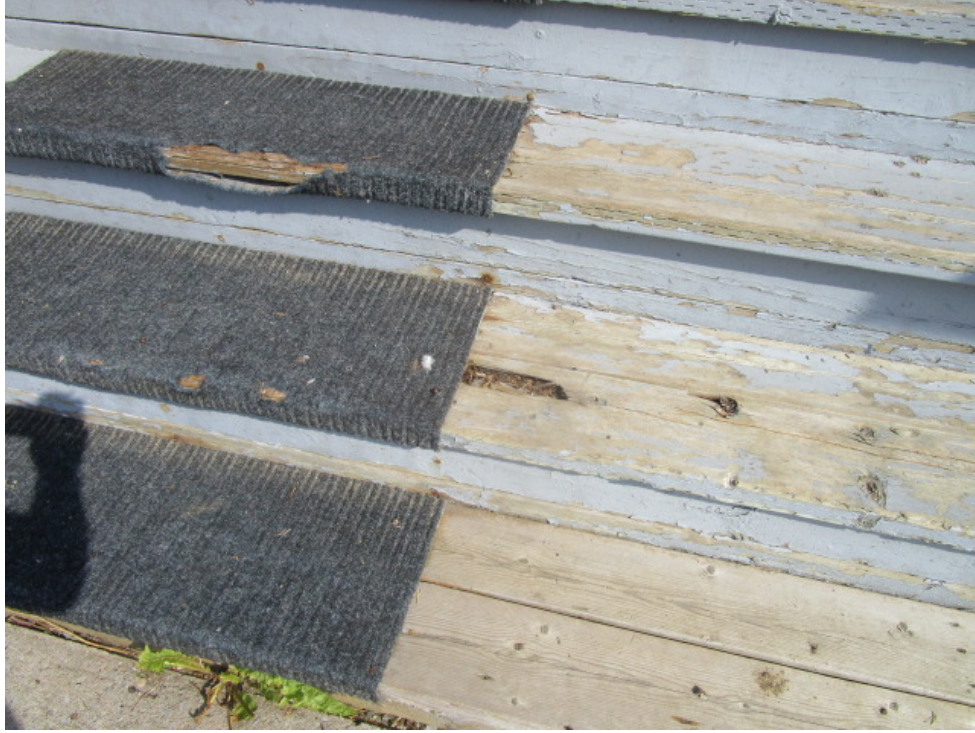
**Photo 23 – Front Entrance Stair Condition**

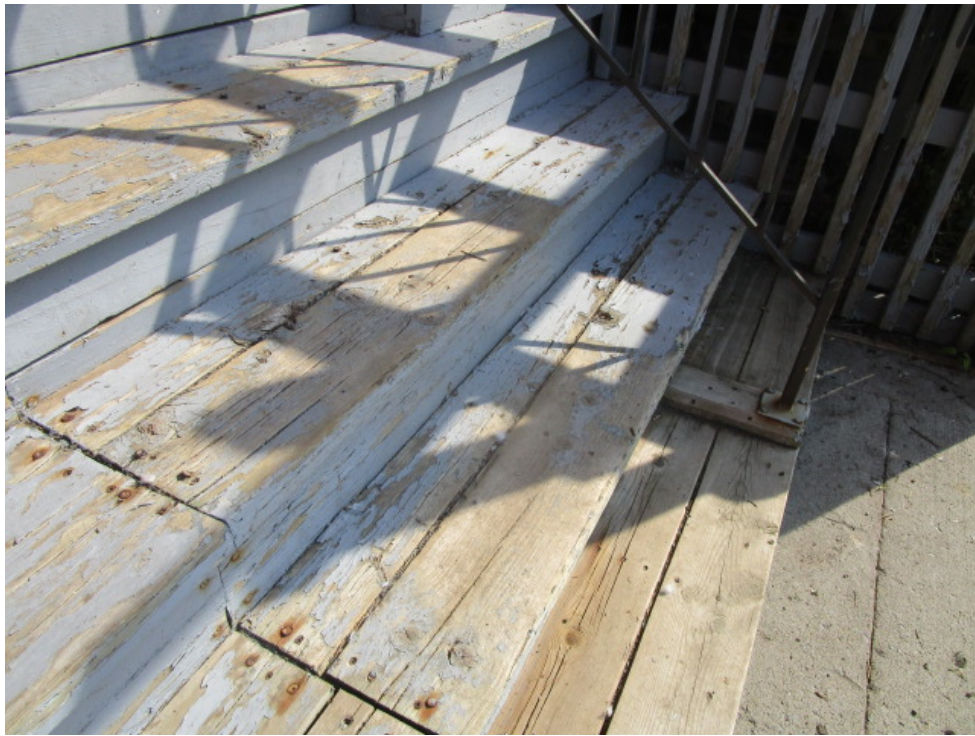
**Photo 24 – Front Entrance Stair Condition**

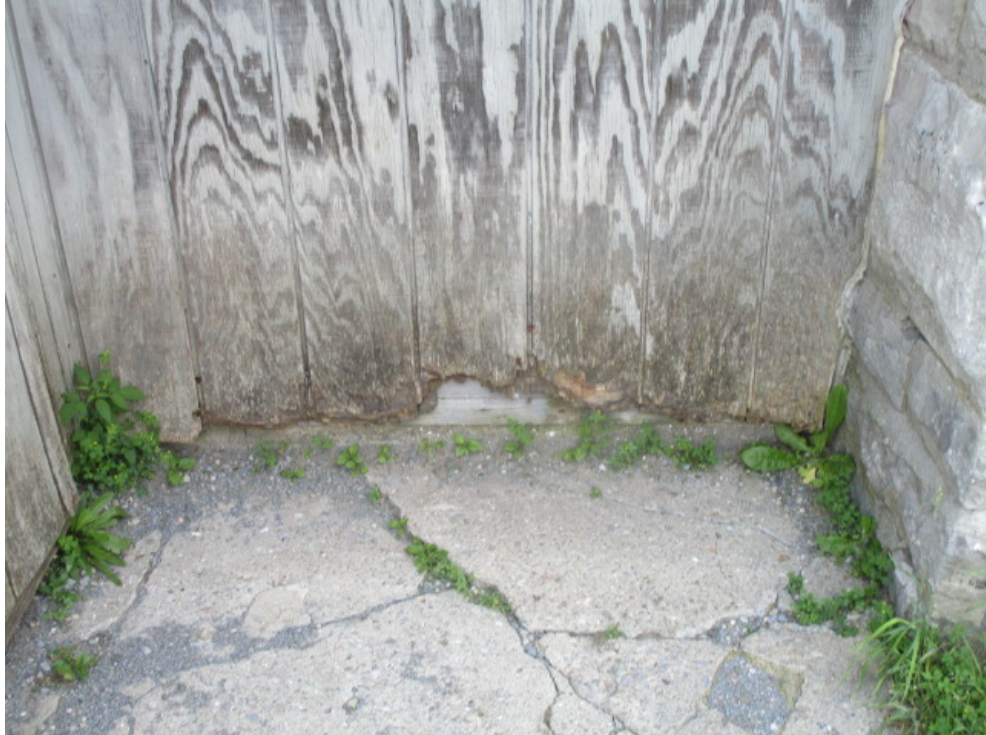
**Photo 25 – North-West Addition Siding Deterioration**

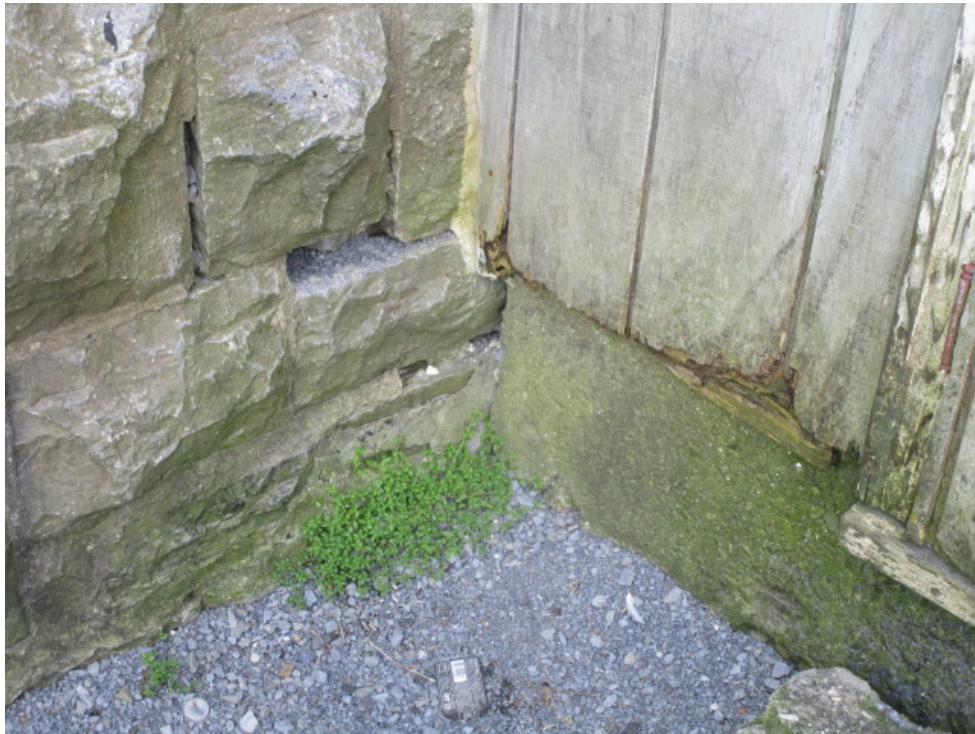
**Photo 26 – North-West Addition Siding Deterioration**

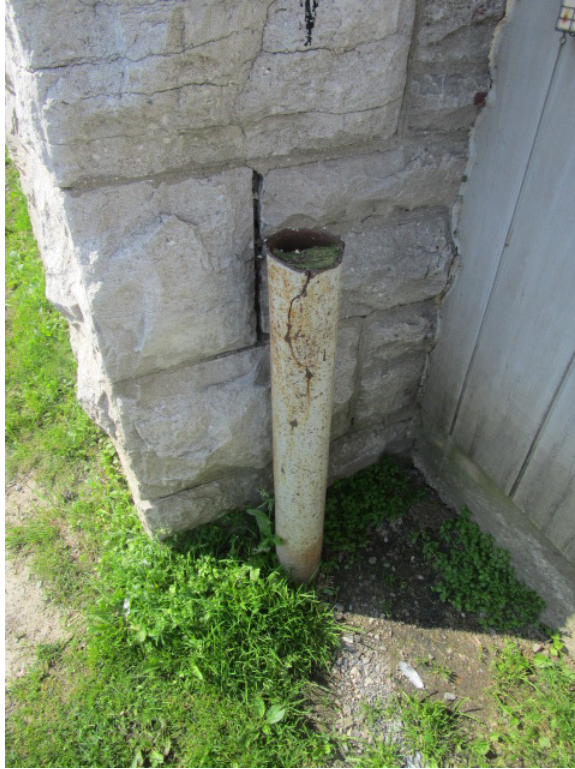
**Photo 27 – Former Drain Pipe At North-East Corner**

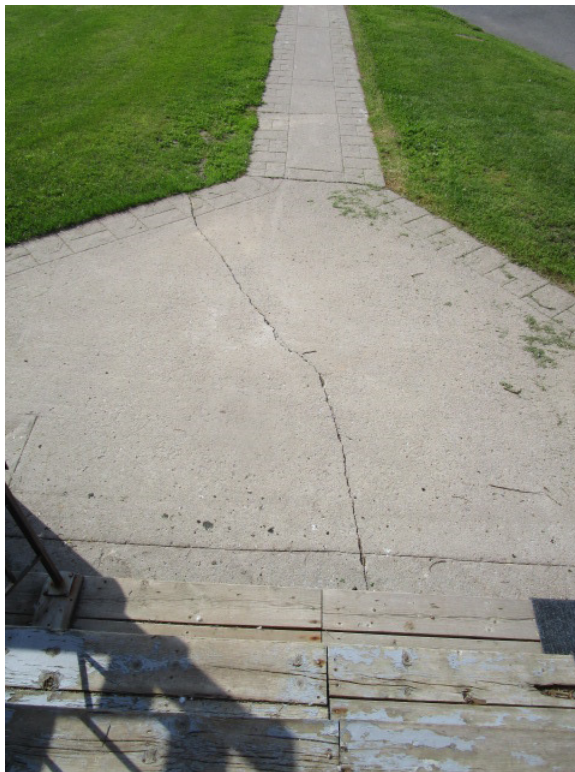
**Photo 28 – South Entrance Slab Cracking**

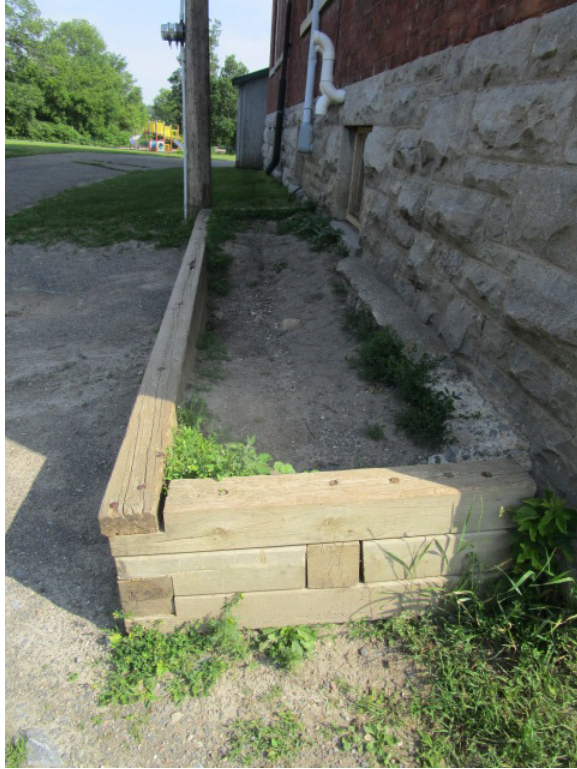
**Photo 29 – West Planter Settlement**

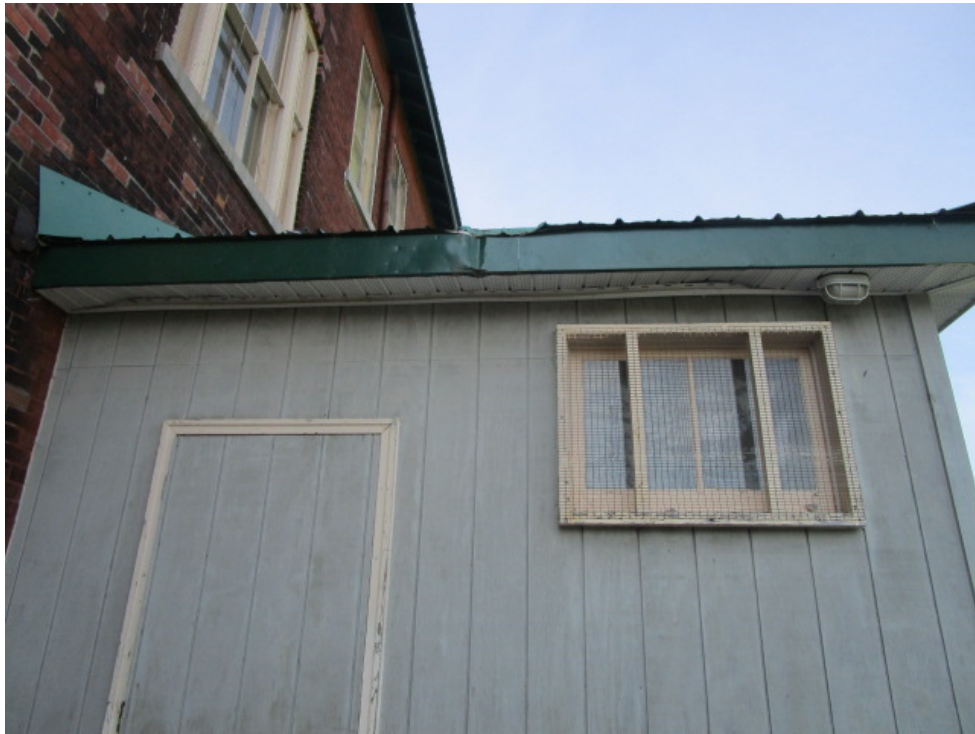
Photo 31 – Damaged Fascia And Soffit

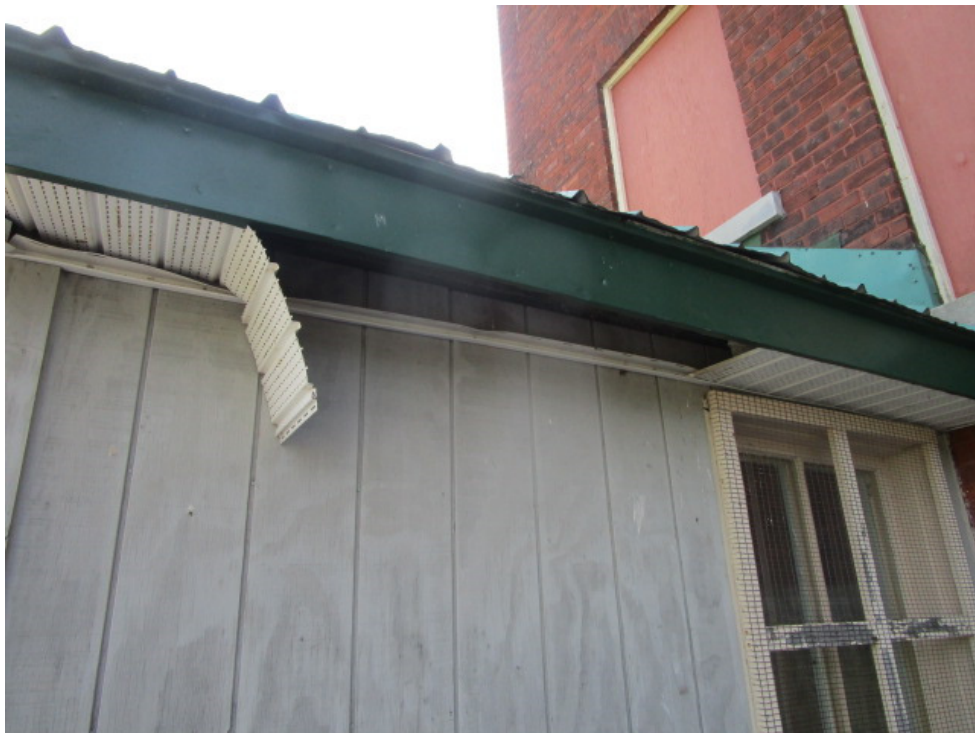
Photo 32 – Damaged Fascia And Soffit

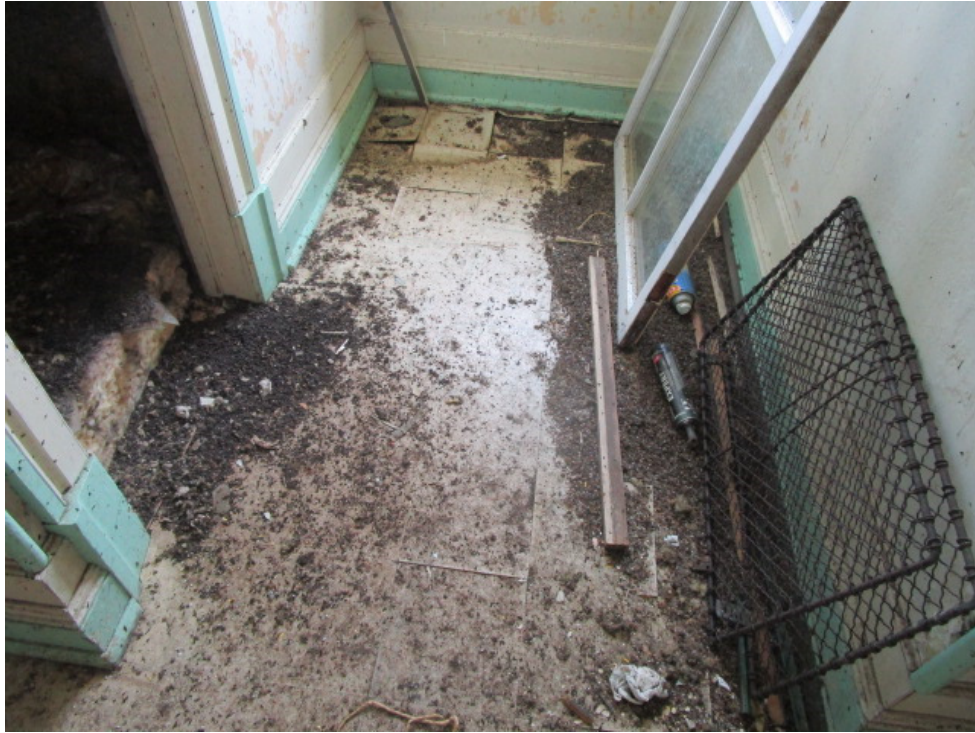
**Photo 33 – Third Floor Batt Droppings**
